HYDROGEN PEROXIDE ACCIDENTS AND INCIDENTS: WHAT WE CAN LEARN FROM HISTORY *

Ben Greene
Honeywell Technology Solutions, Inc.
NASA Johnson Space Center White Sands Test Facility
Las Cruces, New Mexico

David L. Baker
NASA Johnson Space Center White Sands Test Facility
Las Cruces, New Mexico

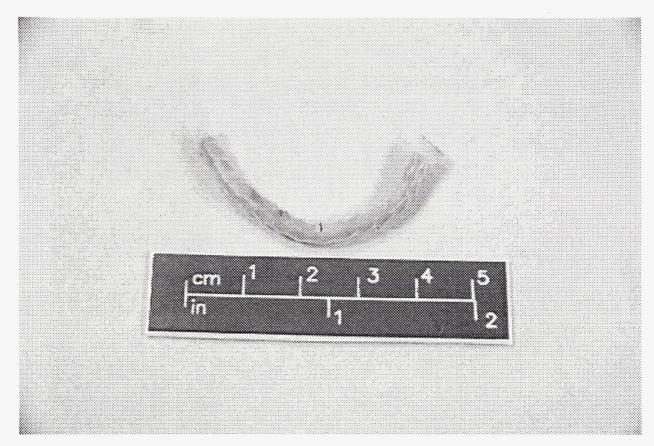
Figure 1. Carbon Steel Shrink-Wrapped Test Specimen

The test specimen was a mild carbon steel, approximately 6-cm long with a 0.25-cm outer diameter, and was shrink-wrapped in fluorinated ethylene propylene (Teflon® FEP). The Teflon® FEP sheath exposed portions of the carbon steel surface and is shown in Figure 1. A 150-mL beaker was charged with 50 mL of 98 percent hydrogen peroxide (FMC), and a sheathed thermocouple was immersed in the fluid until the temperature equilibrated. The test specimen was then immersed in the fluid and the reaction and temperature were monitored periodically for 24 h.

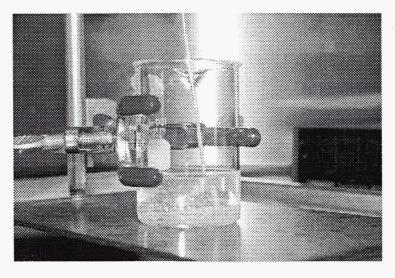
Figure 2. Reaction Mixture after 24-h Period

The failure of a Class 1 protective liner in contact with a Class 4 metal has been reported elsewhere. Our experimental results from the simulated failed liner test showed that hydrogen peroxide in contact with a carbon-steel gradually decomposed. Figure 2 is a photograph of the reaction mixture after the 24-h period. Although oxygen was evolved, there was no significant temperature rise over the 24-h period because the reaction was mild and gradual in the open beaker in the constant air stream of the fume hood. Had this occurred in a storage vessel or in a system without adequate pressure relief, severe consequences as a result of accelerated hydrogen peroxide decomposition, such as expulsion of liquid through a vent or an explosion, could have occurred.

While best practices dictate that hydrogen peroxide systems, including pumps, should be constructed of highly compatible materials, similar considerations should apply to the safe packaging and transportation of hydrogen peroxide. The packaging requirements for shipping hydrogen peroxide were clearly spelled out in paragraph 5 of MIL-P-16005E, 4 and exceeded those required by the Department of Transportation (DOT). However, when MIL-P-16005E was cancelled, responsibility for the selection of suitable DOT-approved packagings became that of the user and the shipping organization. There are several issues associated with the selection of packagings, but one of the most important is that DOTallowed combination packaging may create unsafe conditions. Thorough discussions of some of the concerns and problems associated with the shipping of propellant HP have been reported. 5, 6, 7, 8 As thev pertain to the failed protective liner experiment and events reported elsewhere, decades of knowledge and experience that had been put into the very clearly stated transportation requirements of MIL-P-16005E may be lost. By conforming only to the DOT requirements, a threat to safe transportation and use may be created. An example of a DOT-allowable non-bulk combination packaging is a stainless steel drum and a Teflon® liner.8 Such a combination is a potential hazard for reasons that include failure of the Teflon® liner. This could permit prolonged contact of hydrogen peroxide with the stainless steel, resulting in leaching of iron, nickel, and chromium into the hydrogen peroxide. The contaminated hydrogen peroxide could then begin to decompose and pressurize the drum. If the contamination is sufficient, over-pressurization may cause structural failure of the drum even if a vent is provided.

Our experiment illustrates this possibility. These above examples further demonstrate the need to understand the history of the development of safe packagings for hydrogen peroxide.

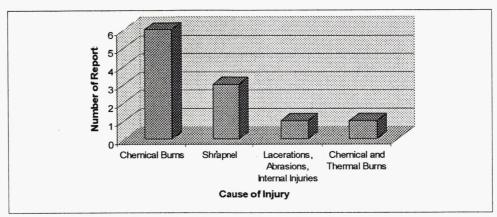
Figure 5. Effects of Explosive Mixtures

There were 13 accident reports in which the cause was an explosive mixture of hydrogen peroxide and other materials or in systems. Of these 13 reports, there were six causes of injury due to chemical burns, three causes of injury due to shrapnel, one cause of injury due to lacerations, abrasions, and internal injuries, and one cause of injury due to chemical and thermal burns. This is illustrated in Figure 5. There were two fatalities in which the causes were explosive mixtures; these fell in the cause of injury category due to shrapnel and were discussed earlier. 20, 24

Each of the events described in these reports can be attributed directly or in part to the consequences of mixing hydrogen peroxide and reactive materials.
